PYRGI: ANALYSIS OF POSSIBLE CLIMATIC EFFECTS ON A COASTAL ARCHAEOLOGICAL SITE

Abstract – This work refers to an interdisciplinary study on the archaeological site of Pyrgi, an Etruscan harbour still under excavation, located on the Lazio's coast in Santa Severa, in the province of Rome. The site in question is subject to frequent flooding which compromises its accessibility and delays the archaeological excavation operations. The study is based on the combined use of geomatic technologies, meteorological and climatic models, and hydrogeological knowledge of the examined site, to have a global view of the hazard to which it is exposed. Different geomatic techniques at different scales are used in the analysis. Large scale surveys are carried out to define the water networks and to monitor the site using satellite images. On a small scale, drone photogrammetry techniques are used to assess the morphology of the territory and eventual protection from natural hazards present in the site. Using these images, a detailed digital surface model (DSM) has been generated.

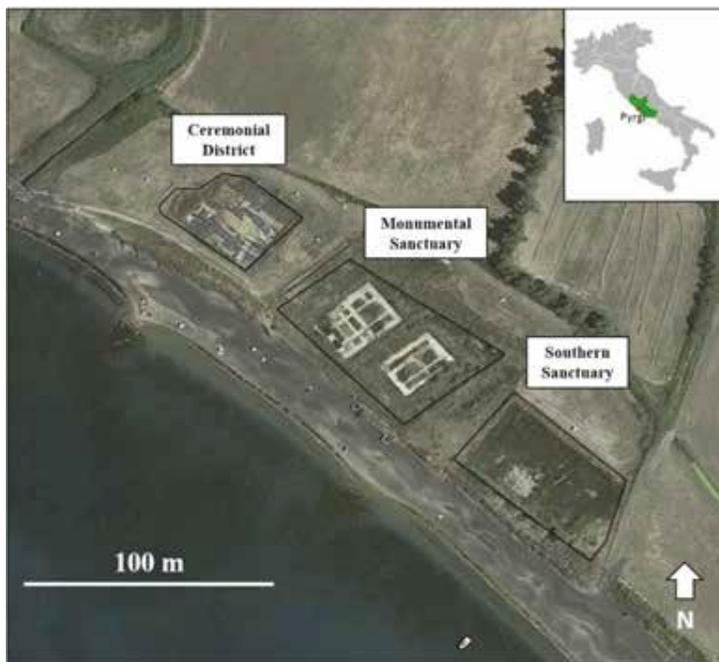
Figure 1 - Geo-localization of Pyrgi and subdivision of the sanctuary complex: at the top left Ceremonial District; in the centre the Monumental Sanctuary; at the bottom right the Southern Sanctuary. (Google Earth Image © 2020 TerraMetrics ©2020 Google).

The case study is Pyrgi, an Etruscan harbour still under excavation, supervised by the Sapienza University of Rome, Department of Classic in particular under the Scientific Responsibility of Professor Laura Michetti, located along the Lazio coast in Santa Severa (RM) (Figure 1) [2]. As can be seen in Figure 1 the site is located only a few meters from the coastline.

Pyrgi was the harbour of an ancient Etruscan city, Caere, and played a fundamental role in maritime transport, being frequented by Greek and Phoenician ships. The emerged area includes a ceremonial district and two different sanctuary areas: Monumental and Southern (Figure 1) [2] [8] [12]. A consistent part of the area is completely submerged by the sea that includes the harbour site [1] [2] [7] [16].

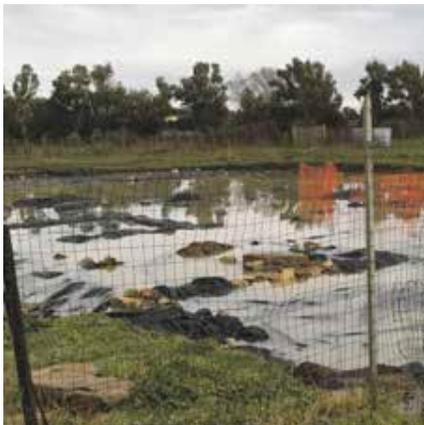
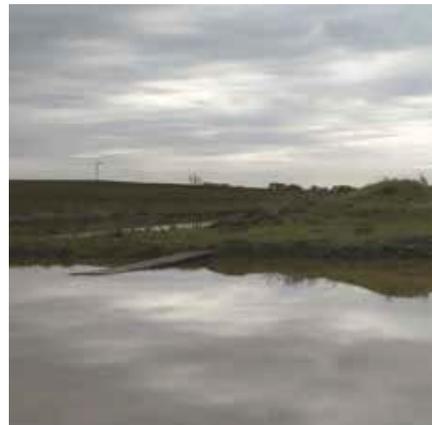
a) Ceremonial District

b) Monumental Sanctuary

Figure 2 - View of the flooded archaeological site after the thunderstorm of 15th November 2019 (photos by the authors taken on 20th November 2019).

Over the years, the site has suffered repeatedly flooding events, characterized by a strong transport of solid sludge and permanence of water in the site, which can cause damage, delay of the archaeological excavation work, and a complete submersion of the site in the future [1]. In the area under consideration, as can be seen in Figure 1, no structures built over the ground exist, but ruins located at lower ground level, potentially transforming into large basins of water after a heavy storm and consequent floods (Figure 2).

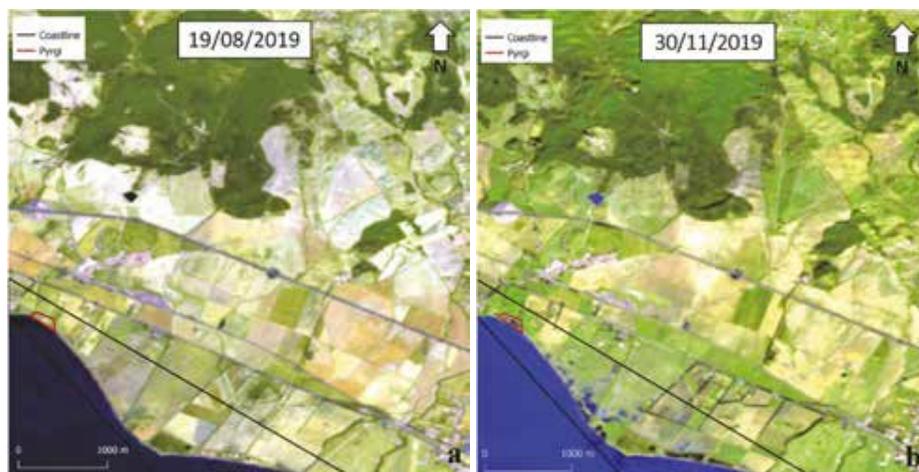
Figure 3 - Comparison of images captured by Sentinel 2-A and processed with Google Earth Engine of the same area in summer, image captured on 19 August 2019 (a), and in autumn, image captured on 30 November 2019 (b).

flooding related to rivers and aquifers. To confirm this, in figure 3-b it can be observed that floods occur only along the coast and not in the hinterland.

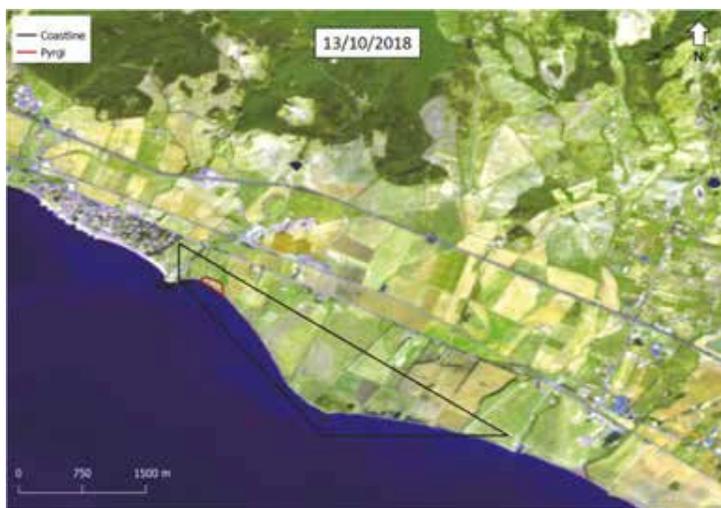
Figure 4 - Image, captured in data 13th October 2018, by satellite Sentinel 2-A after a rainfall greater than 60 mm.

Once the component associated with rivers and aquifers was excluded as the main cause of flooding, the contribution of rainy events was examined. The days of heavy rainfall (greater than 60 mm/day) were correlated with the first available satellite image (S2-A) after the event. In this text only one heavy rain event is reported as an example, considering that for all the other analysed heavy rainfall events (from 2012 to date have been identified 17 heavy rainfall events) the site showed the same response. As can be seen from Figure 4, the site is not flooded after the single heavy rainfall event. Considering the extent of the flooded area and the permeability characteristics of the soil [13], the single heavy rainfall event is not sufficient to cause the flooding of the site.

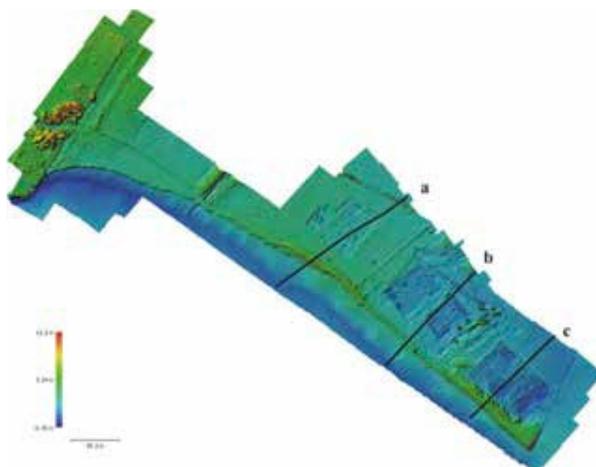
Figure 5 - Digital Surface Model developed with Agisoft®.

Excluding hydrogeological events and severe rainfalls as the principal causes of flooding, sea storms should be analysed. As a first study, it was considered if the site was equipped with sea storm protections. For this purpose, a DSM of the study area was built from drone images (Figure 5), with a resolution of 1.6 cm/pix and point density of 0.391 point/cm². Three sections have been generated, in front of the three principal areas, to highlight the presence of sea storm protection. This specific analysis is derived from the visit to the archaeological site, in which the remains of some dunes were evident, that were created by

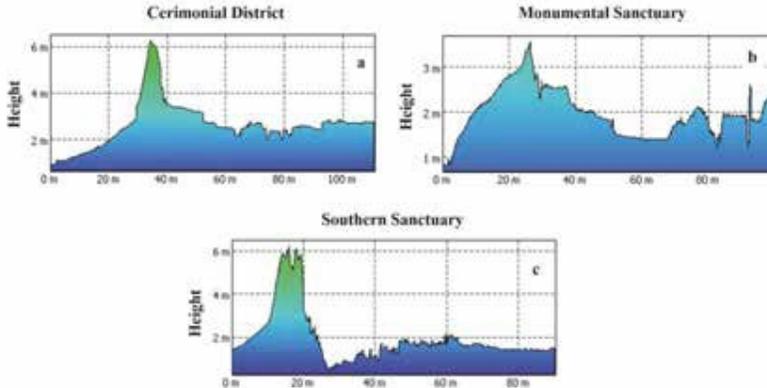
Figure 6 - Surface development in the three different sections shown in Figure 5: Cerimonial District; Monumental Sanctuary; Southern Sanctuary.

accumulating digged ground. Figures 6-a and 6-c show elevations with heights up to 6 m in the boundary line between the site and the beach, associated with storm protection in the area. This, however, is absent in figure 6-b where there are no high elevations and consequently no protection, so the site is exposed to sea dynamics.

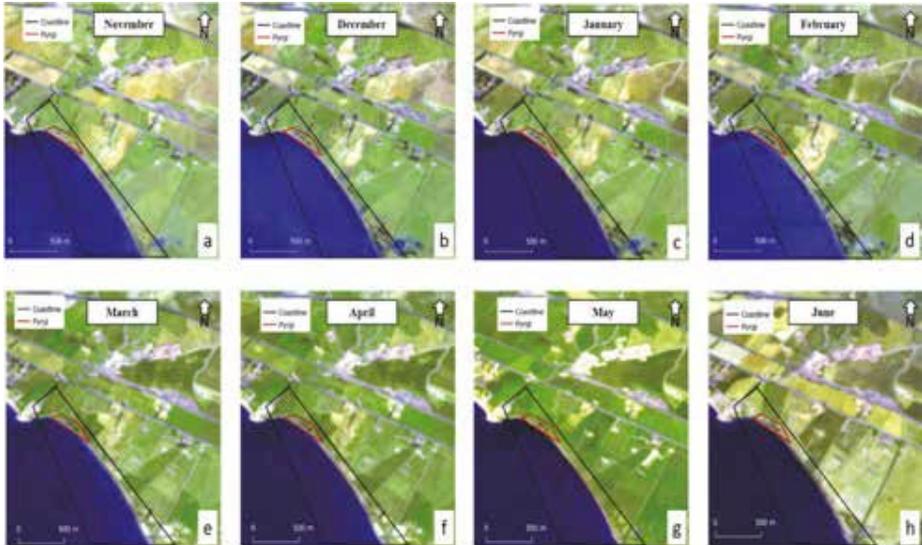
Figure 7 - Pictures taken by Sentinel 2-A and processed with Google Earth Engine for the month of November 2018 (a), December 2018 (b), January 2019 (c), February 2019 (d), March 2019 (e), April 2019 (f), May 2019 (g), June 2019 (h).

To assess if the sea is the primary cause of the flooding of the site the period in which the site is submerged has been identified through S2-A (Figure 7); the site is mainly flooded from November to May. Wind speeds and wave heights are intense during the same months. In particular, the monthly maxima of wave heights are very high, up to 3 m high waves. Also the wind speeds are very high, with peaks over 9 m/s in particular during the autumn and winter months. The data reported do not take tides into account, being the tide variations around 30 cm and so they have been considered negligible in this study.

Upstream of all the analyses, it can be said that the main cause of the flooding at the archaeological area is the maritime component, since the area in which it is exposed to storm surges and the site without adequate protection. It is also noted that in June wind speeds and wave heights decrease and the drying up period of the area begins, lasting several weeks (Figure 7 h).
