THE BUILDING MATERIALS OF THE LORENESE FORTS OF THE TUSCAN COAST

Silvia Rescic, Fabio Fratini, Manuela Mattone

Abstract: This work examines the natural and artificial stone materials (mortars and bricks) used in the construction of the fortifications realized by the Grand Duke of Tuscany Pietro Leopoldo between 1786 and 1793 along the Tuscan coast. The aim is to verify the possible relationship between the materials used and the stone resources and raw materials (clays for bricks and limestone for the production of lime) of the individual territories, or to ascertain a standardised use of materials, with origin from a single production centre. Furthermore, the state of conservation of these fortifications in relation to decay phenomena will be examined, trying to highlight the influence of environmental factors and the characteristics of the stone materials.

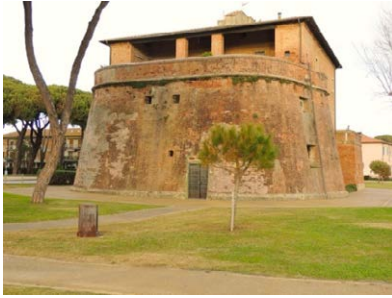
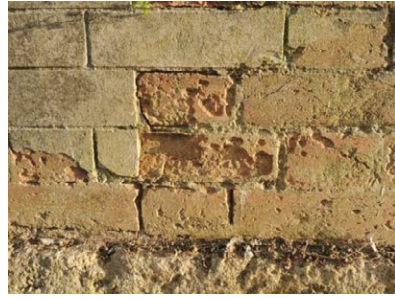
The three structures are clad in bricks: larger those of the rampart (dimensions of 28x 17 x 8 cm), shaped to have a smooth surface toward the outside, and set with thin mortar joints (0.5 cm thick); smaller the ones of the central tower and courtyard wall (dimensions of 25 x 12.5 x 4 cm) laid with thick mortar joints. The base of the rampart consists of a plinth in Pietra Panchina [11], which is also found in the stringcourse frame of the rampart itself and in the opening frames of the tower building. The jambs and the pointed vault of the access to the rear courtyard are in organic limestone. Nowadays, the building is abandoned. A restoration of the masonry was carried out adopting pinkish mortar to reintegrate brick gaps. In the rare places where the mortar fell, the bricks are affected by honeycombing (Fig. 2b). This phenomenon is also present in some of the bricks of the central tower and the courtyard wall, sometimes totally eroded. In addition, the masonry of the north-east courtyard wall is completely covered with lichens.

Figure 2 – Forte San Rocco (a); particular of the alveolisation phenomena that have completely eroded the bricks (b).

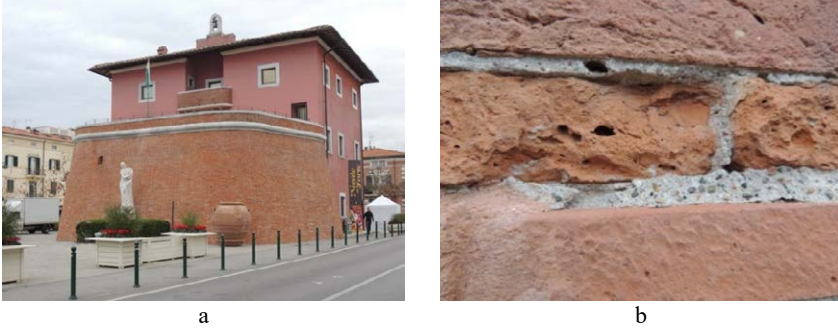
The fort is located approximately 400 m from the shoreline (Fig. 6a). It consists of a bastion facing the sea, made up of a wall about 5 metres high with chamfered corners, surmounted by a large terrace and behind it a two-storey building with a four-sloping roof. The wall is faced with bricks measuring 28.5 x 14 x 3 cm. The mortar joints are about 0.5 cm thick. A base is not observed, but this may be since the current forecourt surrounding the fort is at a higher level than the original one. The stringcourse cornice and the openings of the tower building are made of white veined marble. The tower building is completely plastered, and therefore it is not possible to observe the masonry apparatus.

Figure 6 – Forte dei Marmi (a); particular of re-pointed mortar and brick erosion phenomena (b).

The building was completely restored in 2004, and it is in good condition. During the restoration work, the most decayed bricks, especially those affected by honeycombing and spalling phenomena, were integrated with a mortar imitating the bricks themselves, others were replaced, and the mortar joints were re-pointed (Fig. 6b). Some of the decayed bricks showing spalling phenomena are still visible (Fig. 6b). The marble architectural elements are in excellent condition but given the long years of exposure to weathering and marine aerosols, it is probable that they were replaced with new ones during the restoration.
